WEST MICHIGAN HOME INSPECTORS LLC
3134 Chamberlain SE
Grand Rapids MI 49508
616-443-0946

Client Information: Record Number 4230

Inspected 9/10/12 8:30 AM

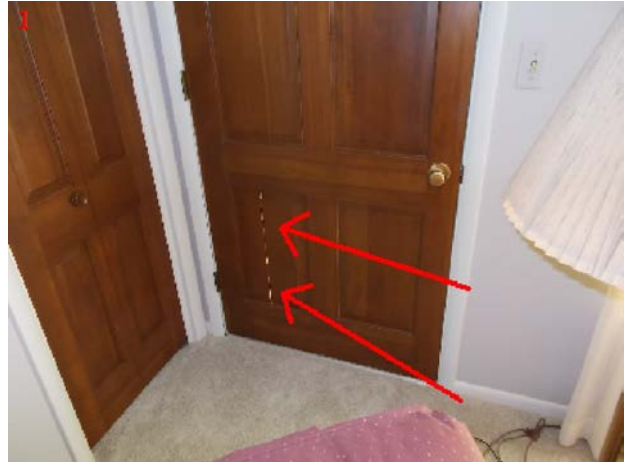
Entry Doors

The front door is cracked, daylight can be seen through the door. It maybe time to replaced the door with an insulated door.

The front door is cracked, daylight can be seen through the door. It maybe time to replaced the door with an insulated door.

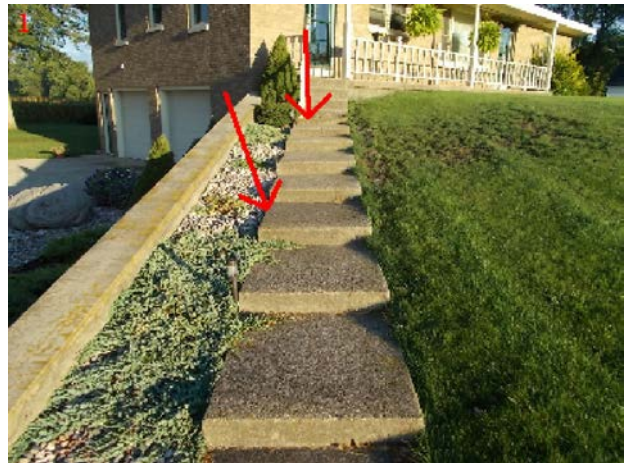
Steps

Cracks and some settlement noted. The front steps have settled.

Cracks and some settlement noted. The front steps have settled.

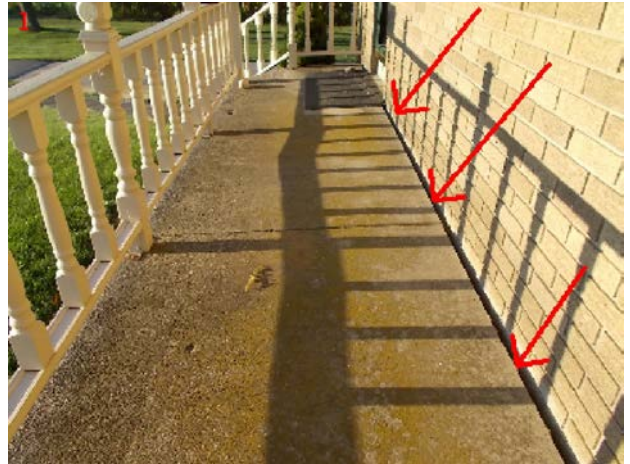
Porches

The front porch has settled and pulled away from the house.

The front porch has settled and pulled away from the house.

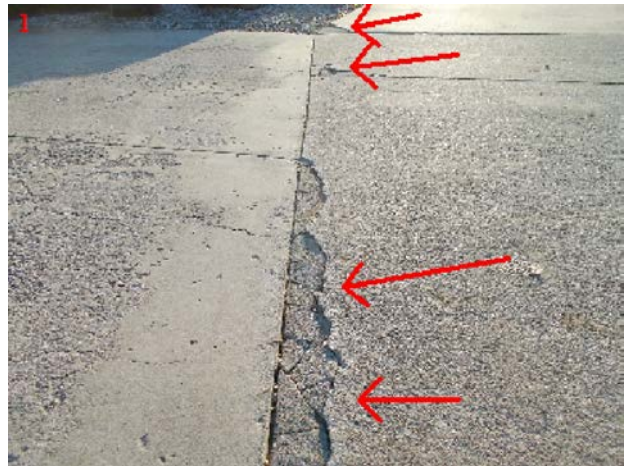
Driveway

Some cracks noted.
Uneven areas may present a tripping hazard and should be repaired to prevent injury.

Some cracks noted.
Uneven areas may present a tripping hazard and should be repaired to prevent injury.

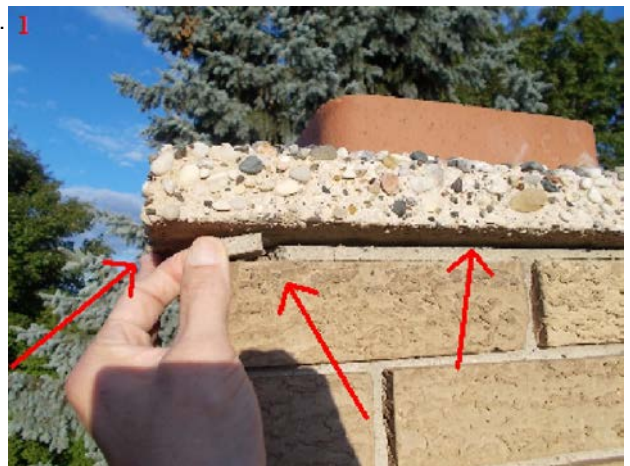
Chimney 1 Type

Some loose mortar toward the top of the chimney should be repaired.

Some loose mortar toward the top of the chimney should be repaired.

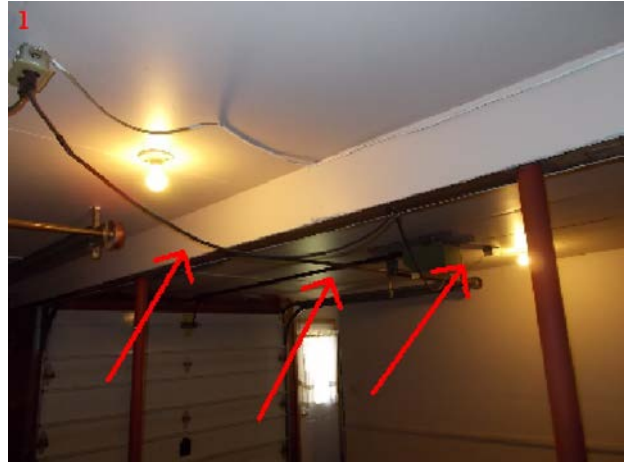
Garage Electrical System

The garage electrical outlets are grounded. For safety it is recommended that GFCI outlets installed. The garage lighting was fed with extension cords, which should be removed and replaced with permanent wiring.

The garage electrical outlets are grounded. For safety it is recommended that GFCI outlets installed.
The garage lighting was fed with extension cords, which should be removed and replaced with permanent wiring.

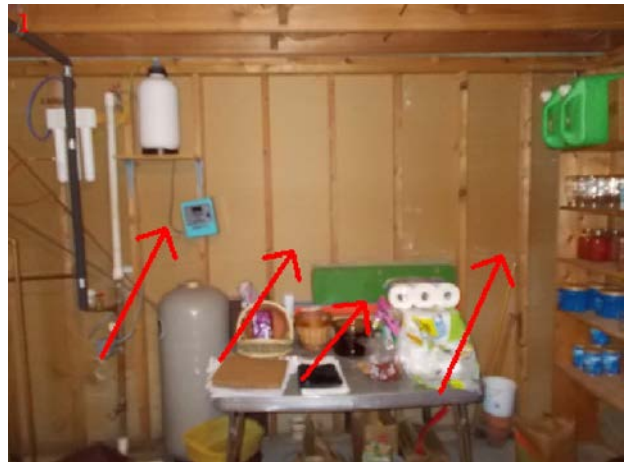
Interior Walls

The wall between the garage and the basement is not insulated. To save energy this wall should be insulated.

The wall between the garage and the basement is not insulated. To save energy this wall should be insulated.

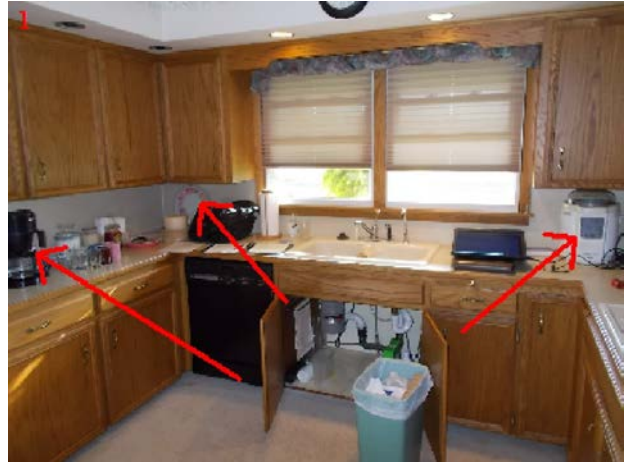
Kitchen Wall Receptacles

Recommend adding GFCI outlets in areas near water.

Recommend adding GFCI outlets in areas near water.

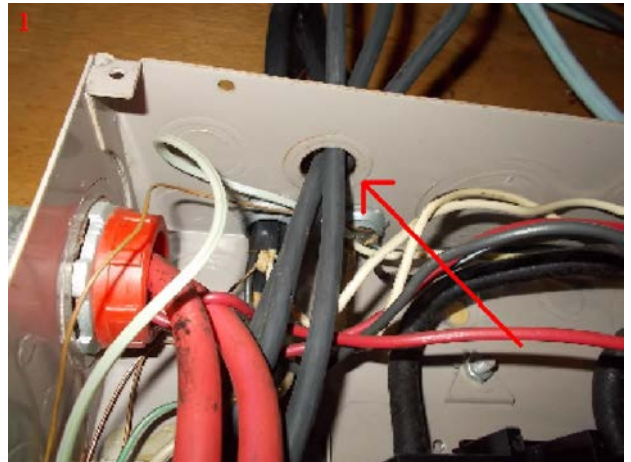
Main Electrical Disconnect

Missing wire protector should be installed on the wires going into the heating panel.

Missing wire protector should be installed on the wires going into the heating panel.

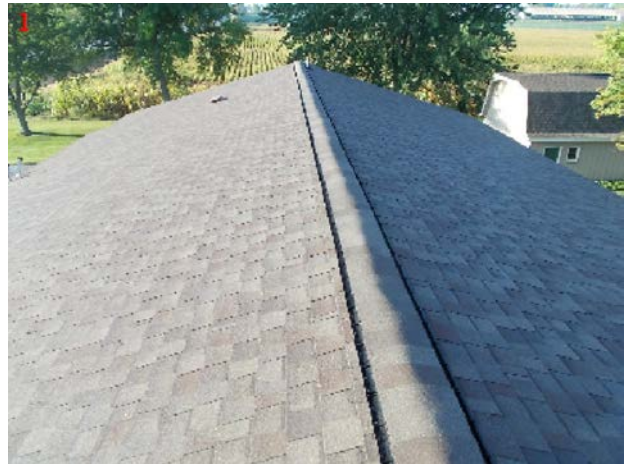
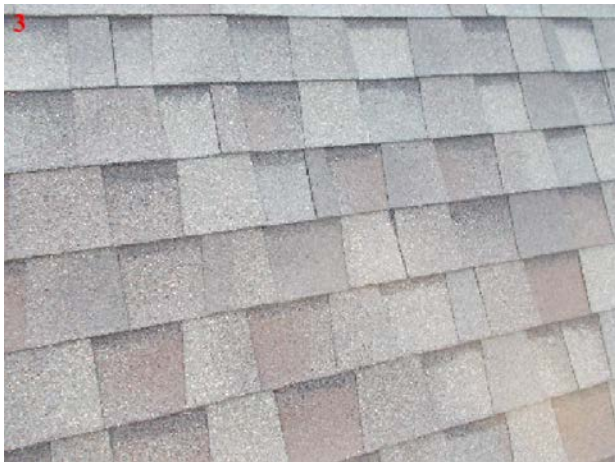
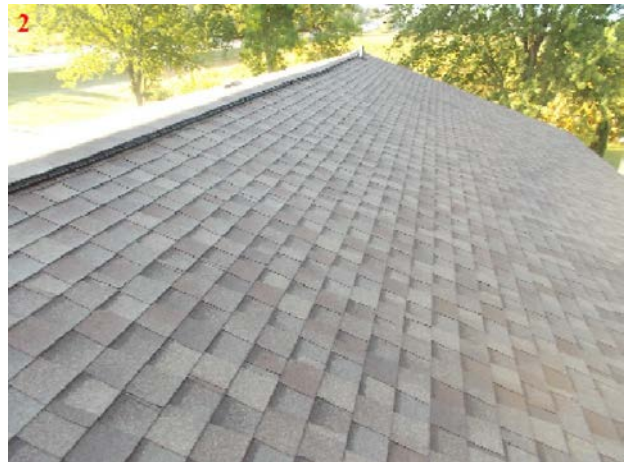
Roof Covering

The shingles are in good condition. The pictures are for information only.

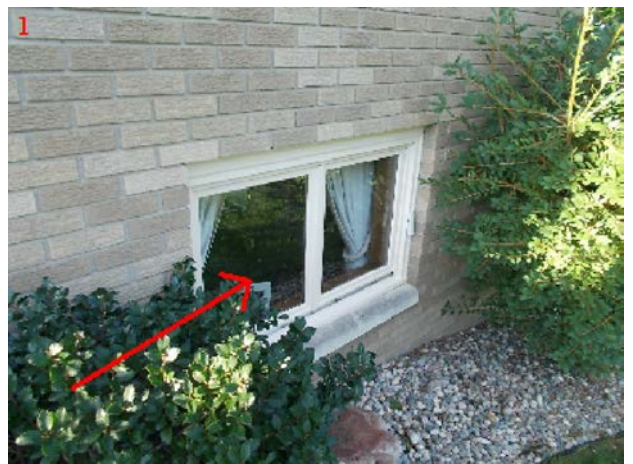
Window Character Material

All the windows have been replaced except the basement side window. This is still a single pane window.

All the windows have been replaced except the basement side window. This is still a single pane window.

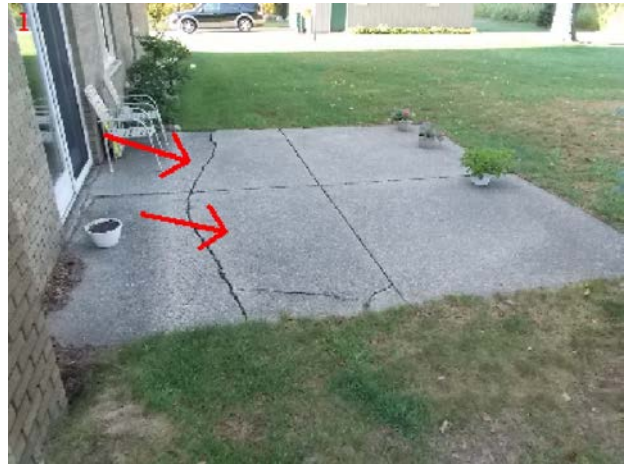
Patio

Cracks and settlement were noted.

Cracks and settlement were noted.

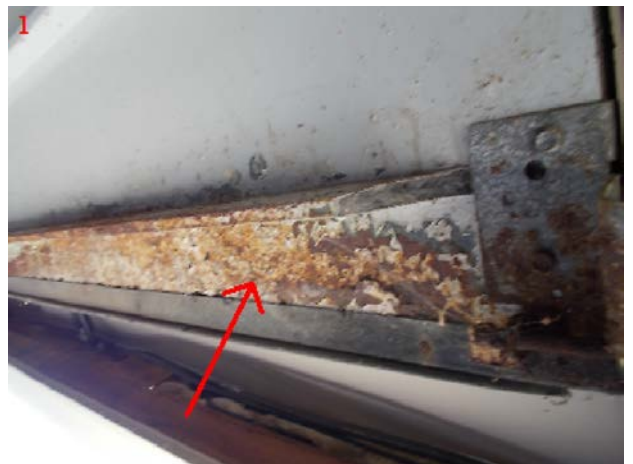
Garage Doors

Some rust noted on the bottom of the door.

Some rust noted on the bottom of the door.

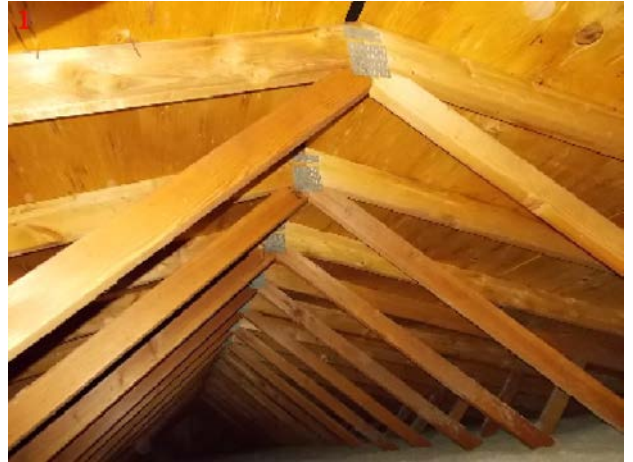
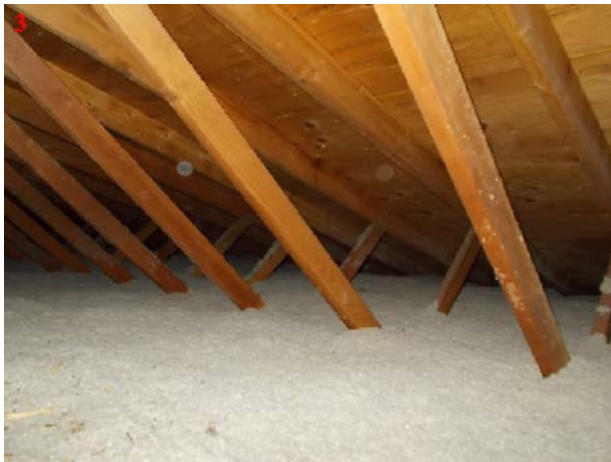
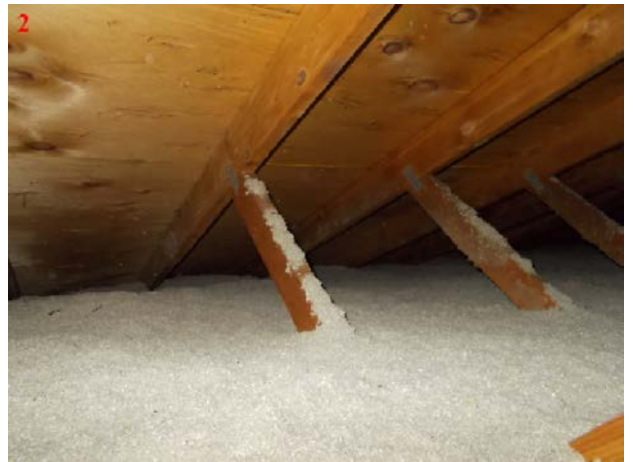
Monitor/Maintain Attic Insulation Thickness - 10 plus inches

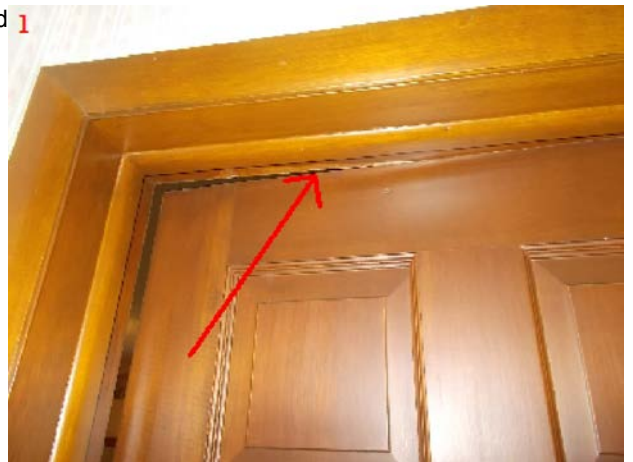
Closets

The master bedroom door does not close and will need to be trimmed to fit.

The master bedroom door does not close and will need to be trimmed to fit.

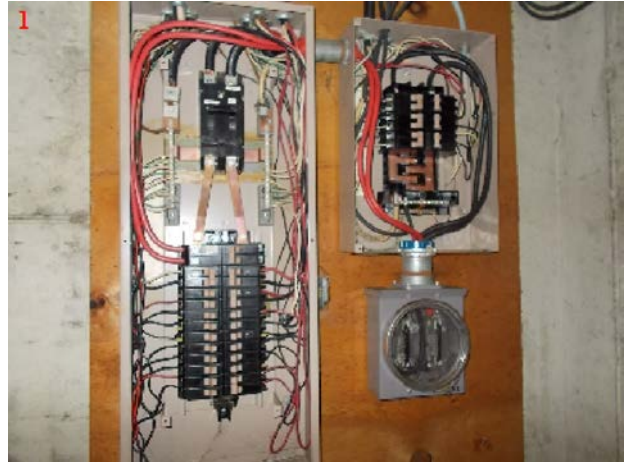
Main Panel

The main panels are in good condition, the pictures are for information only.

The main panels are in good condition, the pictures are for information only.

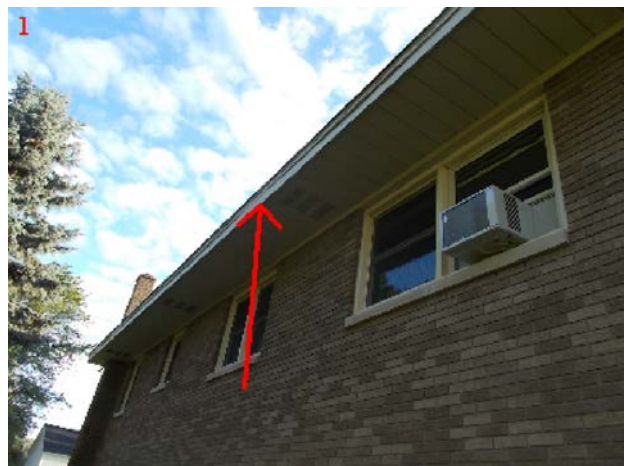
GUTTER SYSTEM

No gutters installed. Recommend adding gutters to prevent water penetration into the basement.

No gutters installed. Recommend adding gutters to prevent water penetration into the basement.

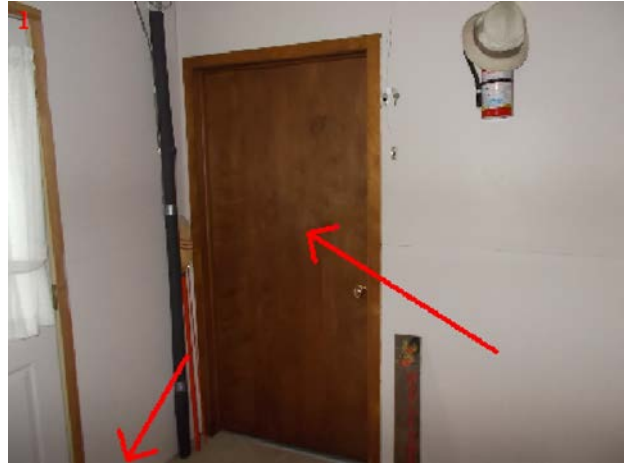
Garage Interior Walls

The doors to the house are not insulated. These you may want to change out.

The doors to the house are not insulated. These you may want to change out.
